**Missouri River Flood 2011
Vulnerabilities Assessment Report
Volume I: Summary**

**Northwestern Division
US Army Corps of Engineers**

October 2012

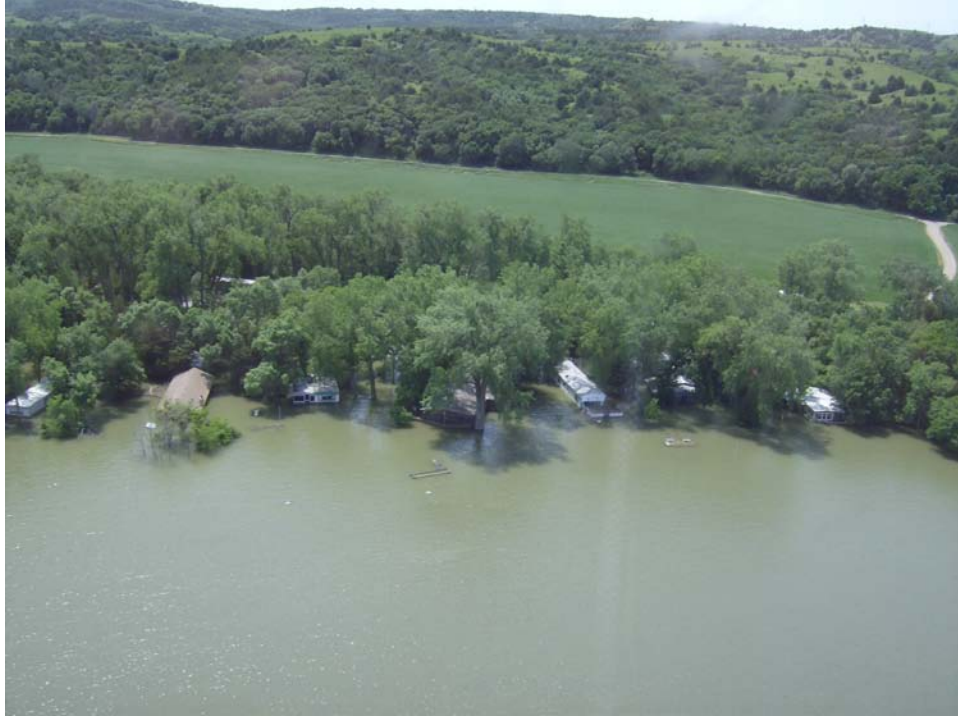
Figure 3. The Missouri River flood of 2011 inundated homes, businesses and agricultural lands. Highways, bridges, railroads, and other infrastructure were also impacted. (Photo taken in June 2011 below Ft. Randall Dam.)

homeowners, farmers, and business owners to evacuate. (Figure 3) Several Missouri River bridges as well as long stretches of interstates, highway, and roads were closed for weeks or months at a time. Approximately 250 miles of railroad tracks were in the flood area, requiring track sections to be raised, temporary berms to be built, and damaged tracks to be repaired. Many road and rail shipments were delayed and rerouted through other states. The upper navigable portion of Missouri River— itself a vital part of the transportation network—was closed to all navigation for several months. All along the river homes were destroyed, agricultural lands were damaged, public and private facilities were impacted, and much pain was suffered. While it is beyond the scope of this report to assess direct or indirect flood damages to non-Corps assets, when computed they are likely to amount to billions of dollars.

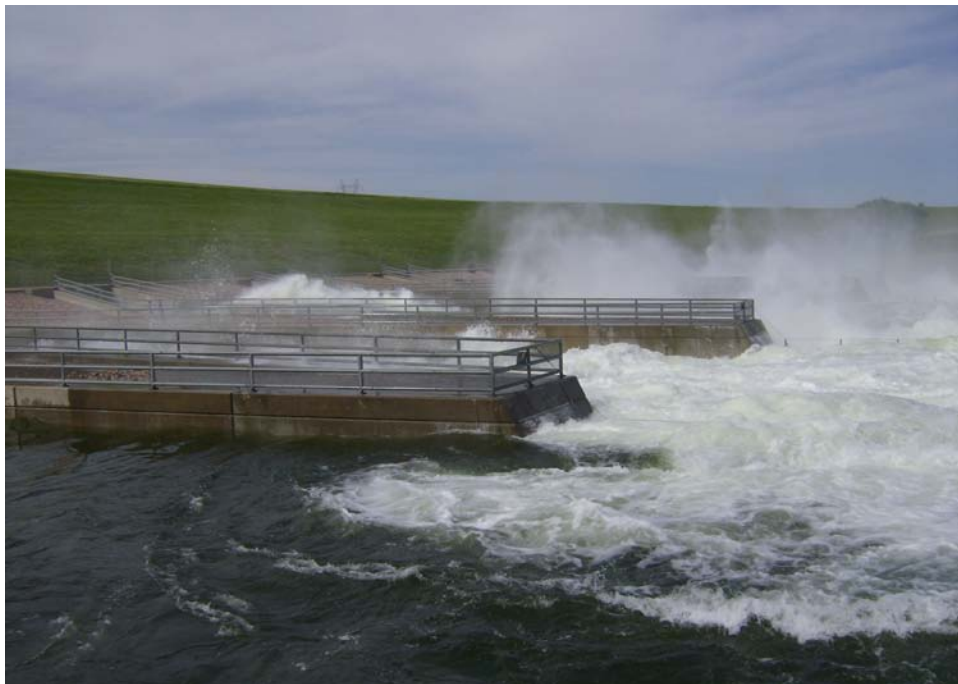
Figure 4. In 2011, the flood tunnels at Oahe Dam released a record volume of water. The earthen-channel spillway (not shown) was not used to avoid damages and the need for costly repairs. (Photo taken June 2011.)

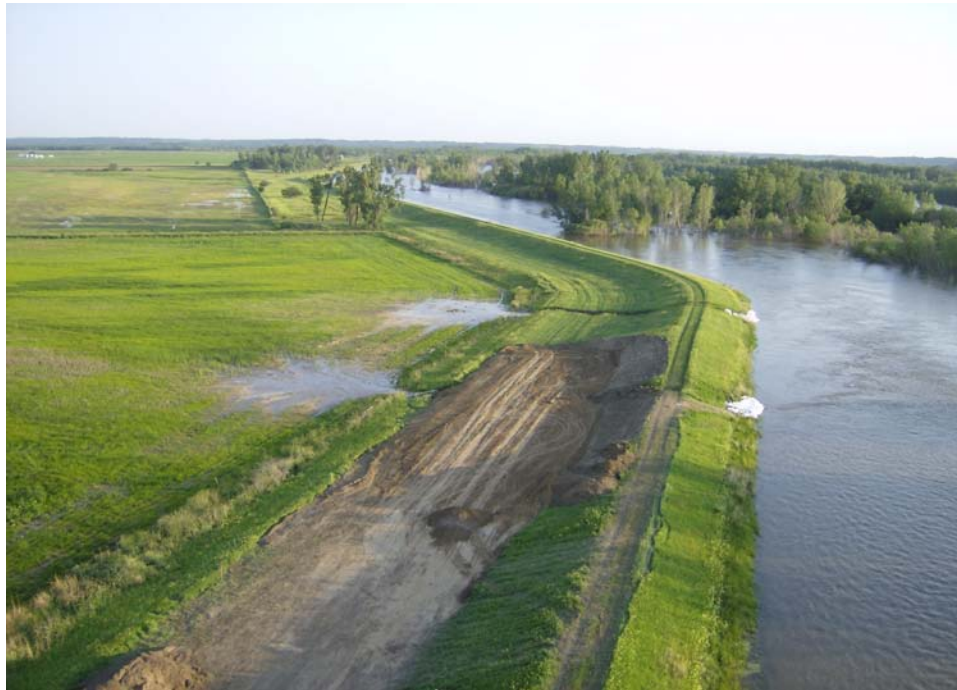
Levees are typically designed and constructed to withstand water loading for a few days or weeks during a year. The 2011 flood subjected the Missouri River levees to months of loading, well beyond the envisioned flood duration. All told, the event caused moderate to extensive damage to roughly 75 federal levees (and many more non-federal levees) within the basin due to overtopping, erosion, and underseepage. (Figure 5) Significant efforts to assess and repair are on-going under the authorities of the Public Law (PL) 84-99 program¹.

Figure 5. The levees along the Missouri River were subjected to prolonged water loading. Consequently, many suffered from erosion and underseepage, necessitating extensive repairs. (Photo taken June 2011 of levee L575 near Hamburg, Iowa.)

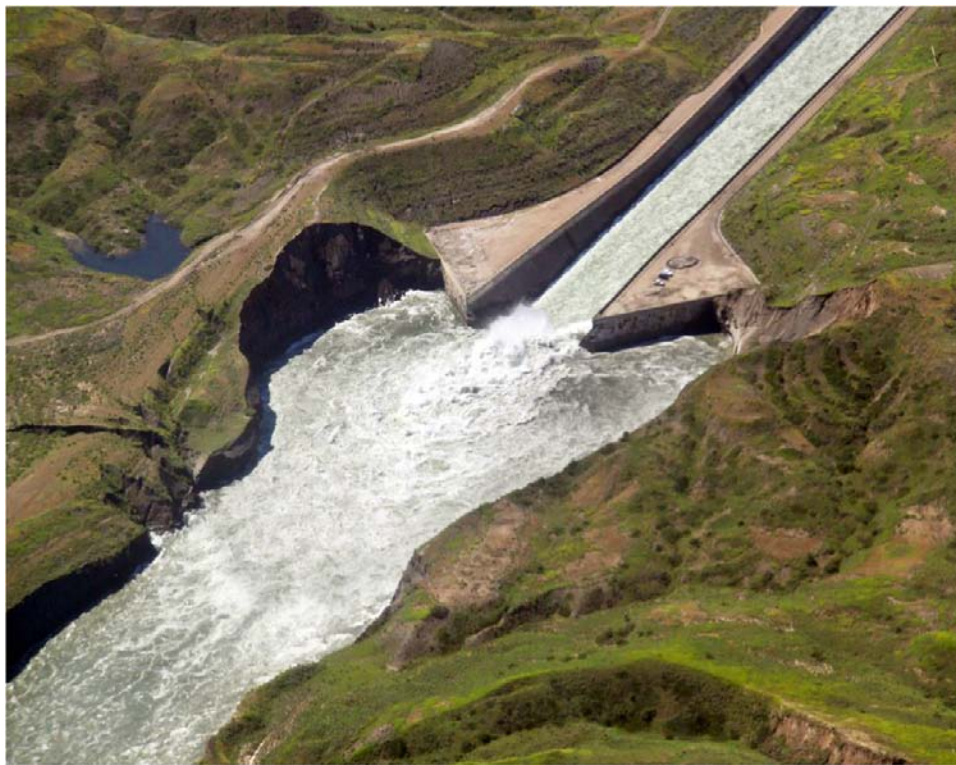
Prolonged, record-level releases caused significant erosion to the spillway plunge pool and damaged the spillway discharge channel. (Figure 6) Although repairs are being completed with DRAA funds for the most immediate erosion damage, there is concern that future sustained high releases might further erode the earth around the west wing wall or uplift the spillway floor slabs, creating a significant dam safety concern. Restoration to return full design function to the spillway could potentially include armoring the plunge pool, reconstructing/reinforcing the cutoff wall and wing walls, modifying the spillway, adding energy dissipaters, or a combination of these measures.

Figure 6. Severe erosion along the wing walls of the Fort Peck spillway plunge pool.
